# Navajo Abandoned Uranium Mine

# Site Screen Report

Mine Name: **Tract 15**Mine ID: **397**

April 2012

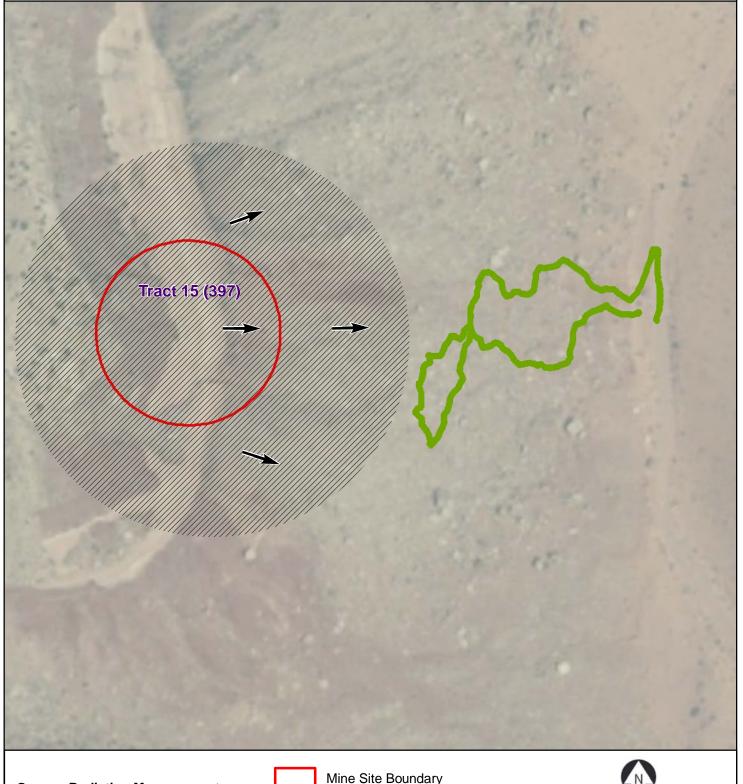
Figure 1 - Gamma Radiation Measurements, Above Two Times Background
Tract 15 (397)
Shonto/Oljato Chapter, Navajo Nation

A total of 1,091 gamma radiation measurements were collected from the mine site, ranging from 7,091 cpm to 13,836 cpm. Weston was unable to access the site, but gamma radiation measurement were collected in the vicinity of the site. The measurements are represented in Figures 1 and 2.
